# **Electrical Equipment “Screams” For Attention!**

## ***Decoding High Frequency “SOS” Calls***

*Joseph Gierlach – Vice President, Technical Training and Support  
TEGG Corporation ~ Pittsburgh, PA*

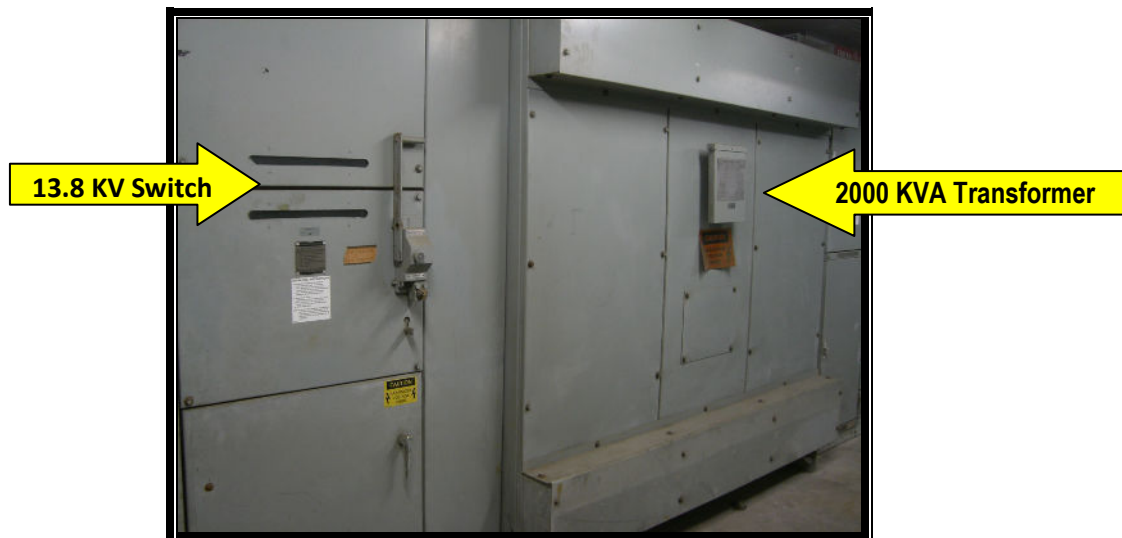
**Figure #1**

As the inspection progressed, Morgan Fowler, lead technician at this time from Transworld Inc., contacted TEGG Corporation personnel to seek opinions of a recording he had secured on one of the 13.8 KV load break switches. This particular switch was one of two identical arrangements that featured the utility feed, a dry 2000 KVA transformer stepping the voltage down to 480/277 volts for distribution to facility equipment. Additionally, this configuration was mirrored on the opposite side of the electrical room to provide redundant supply in the event of an interruption of either of the unit substations. The image in Figure #1 below gives the perspective of the physical lay-out of the one sub:

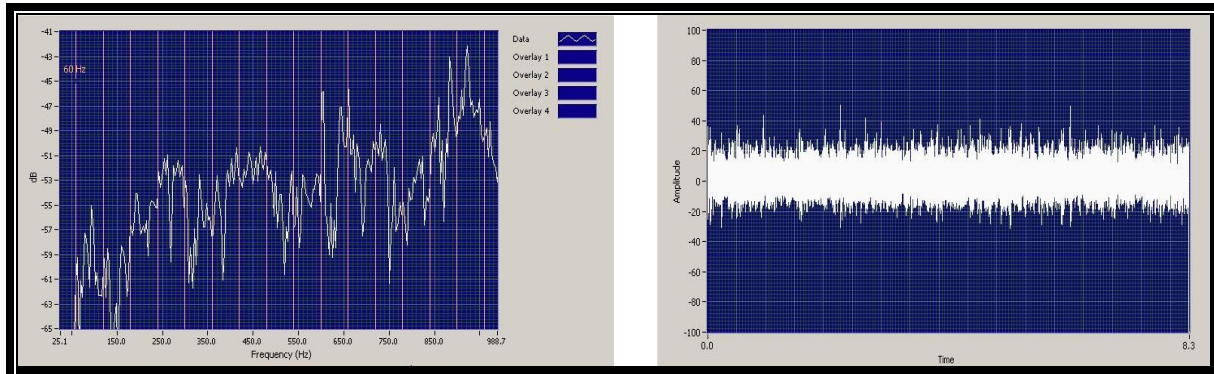
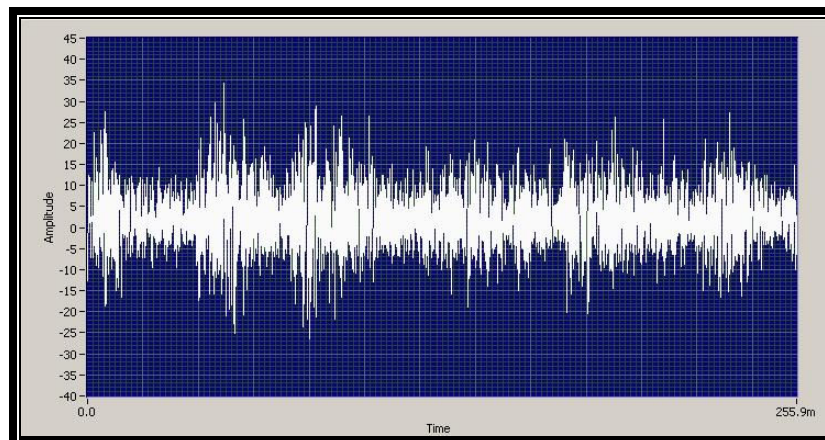
**Figure #3**

The time domain shows a very uniform, linear pattern in which the excursions from the expected broadband of “white noise” throughout the recording are fairly even in spacing (time) and amplitude. This is due to the fact that the ionization process occurs at the negative peak of each electrical sine wave where the potential is at its highest. The 16 ms time base of 60 Hz AC is very predictable and consistent. With Morgan’s anomaly, it was very similar in nature, as can be seen in the spectrums below in Figure #3, although there were not as many “fault frequencies” in the view. The tonal quality, however, was indicative of an electrical fault, and that was factored into the decisions moving forward.

**Here is the “cropped” or “sliced and diced” view of a smaller time frame showing the non-uniform timing and amplitude**

Combining the tonal quality, FFT and time domain view, a scope of work regarding possible repair actions was developed and passed up the chain of command at the hospital. Between July and September 2009, frequent visits were made to the hospital for other maintenance needs, and the switch was checked to determine if there was any progression of the anomaly relative to severity.

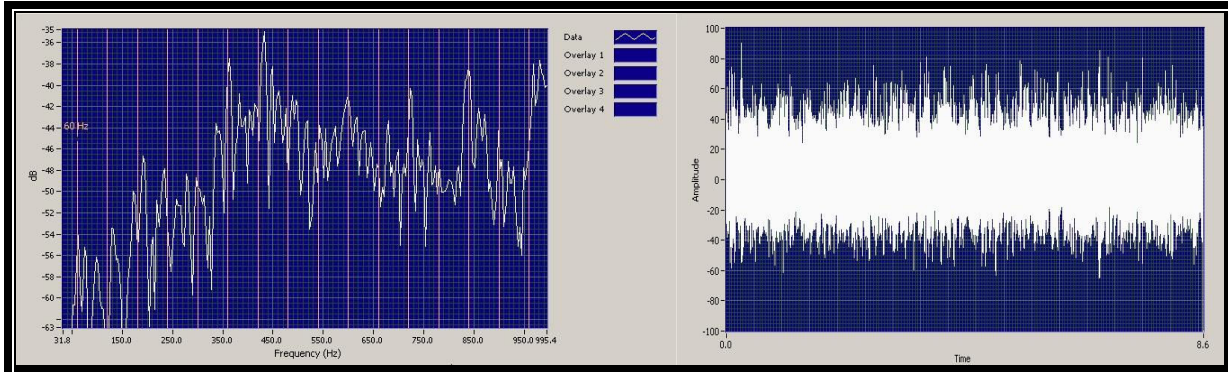
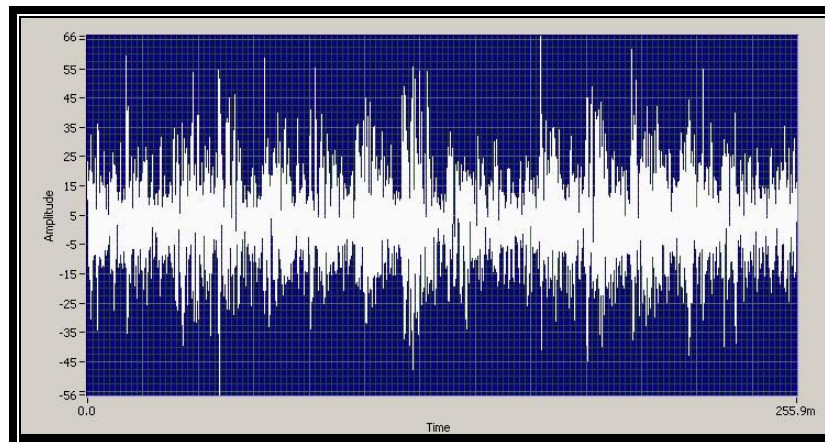
**Figure #4**

**Here is the “cropped” or “sliced and diced” view of a smaller time frame showing the non-uniform timing and amplitude**

(Notice the increase in amplitude and frequency of occurrences)

The qualitative differences in the two recordings’ tonal quality, as well as the spectral content, left no doubt in our minds that the deficiency was indeed degrading in severity, and it was only a matter of time before the device would experience a failure.

Armed with this new data on the fault, we prepared and presented a report of findings to the facility engineer, expressing our concern that maintenance must be done, or the switch most likely was going to fail. Obtaining approval for a shutdown in any hospital proves monumental in scope, as the coordination issues to ensure no critical support systems are interrupted have many built-in redundancies that are checked and re-checked. There are no energized types of maintenance tests on this style of switch other than ultrasonic and visual inspections that yield actionable data. Infrared is not effective due to the line-of-sight issues, and there were no infrared windows installed on this unit. (There is a proposal to install these now under consideration with hospital management.)

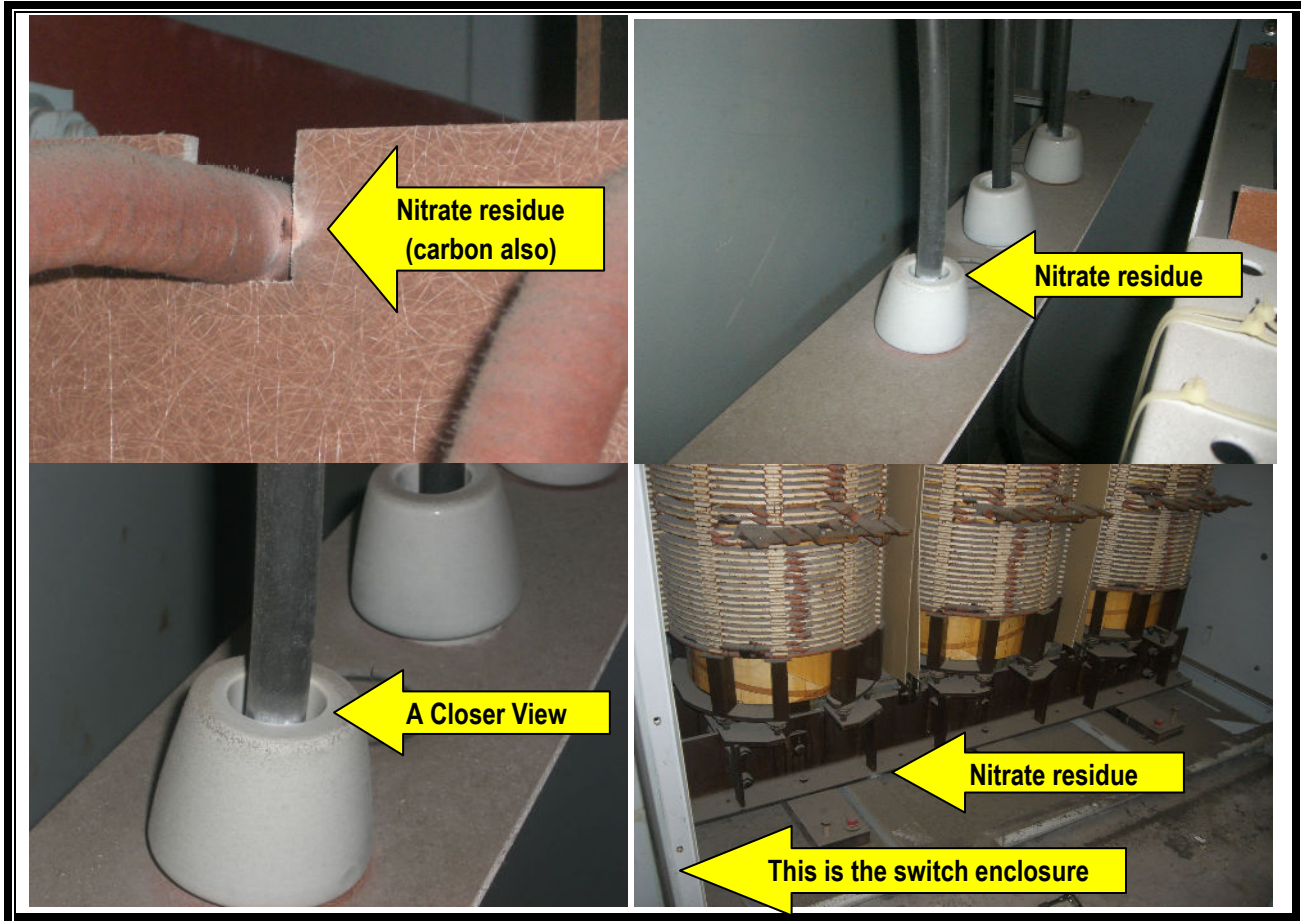
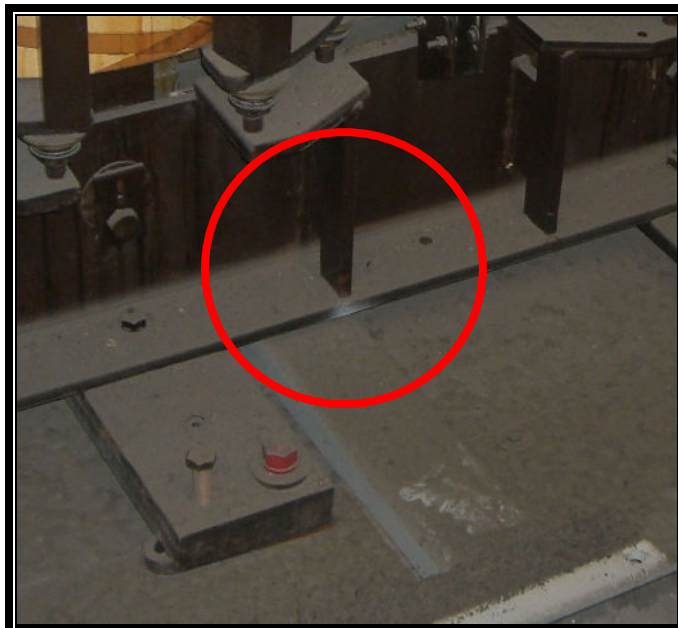
These images illustrate the results of the visual inspection of the switch:

Here is a closer view of the transformer bracket where the nitrates are also visible in the image above:

The visual evidence was indisputable and confirmed beyond any shadow of a doubt that the initial and subsequent analysis and suspicions were correct. The switch conductors and insulators were in fact deteriorating rapidly and in need of maintenance. Due to the curtailed allotment for repairs, a complete replacement of the conductors and insulators was not possible during this visit. The customer agreed to allow Morgan to clean the items as much as reasonably possible, work on the procurement of replacement components, and schedule another visit to complete permanent repairs.

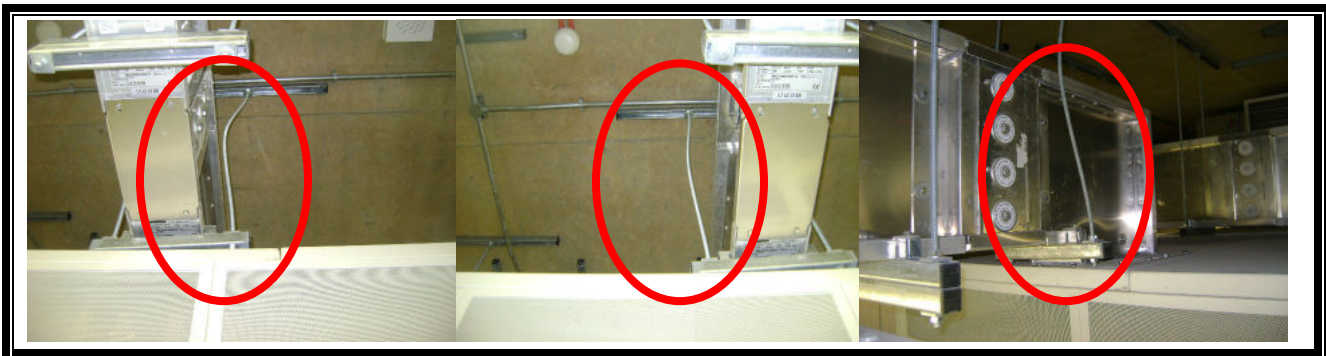
**Figure #5**

The customer called in the local TEGG contractor due to the equipment apparently experiencing structural movement of some sort, resulting in the bus duct/trunking and supports becoming distorted. This can be seen below in Figure #5 with the visual evidence of movement:

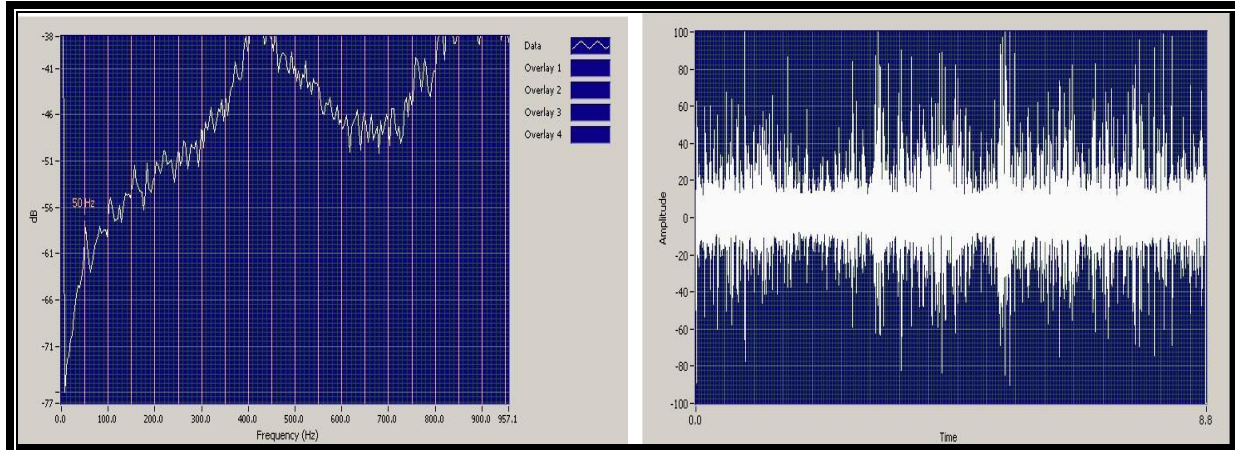
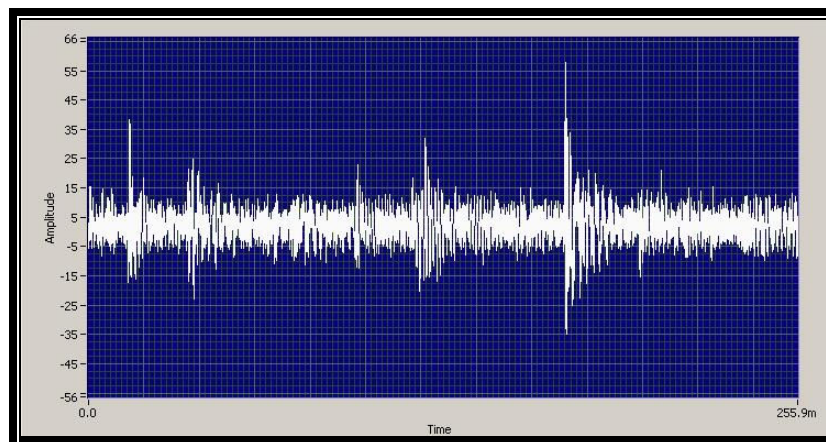
**Figure #6**

As you can see below in Figure #6, there was not much detail in the FFT, however; the time domain had tell-tale signs of a tracking event:

Frequency analysis had no pattern to discern and notably no fault peaks in the spectrum. The time domain over the 8.8-second recording does have “footprints” of a typical tracking event. This means there are three main factors that distinguish this anomaly:

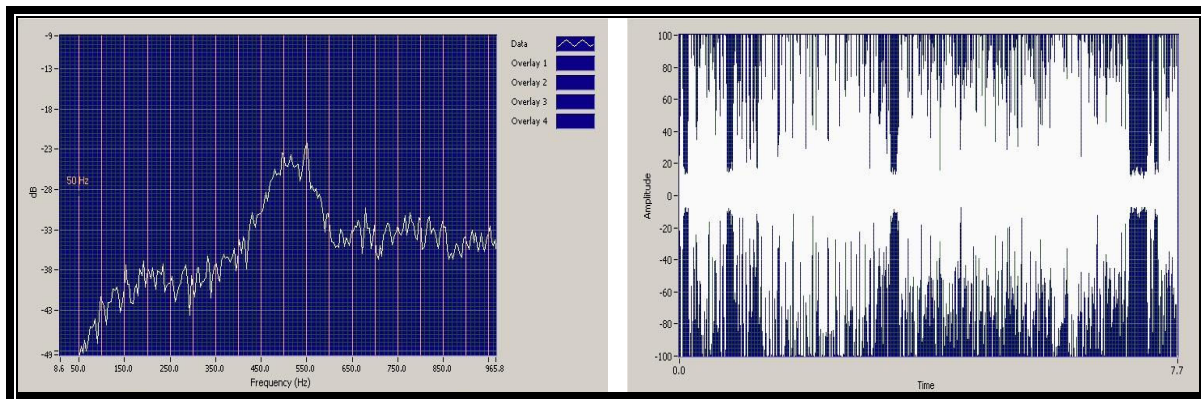
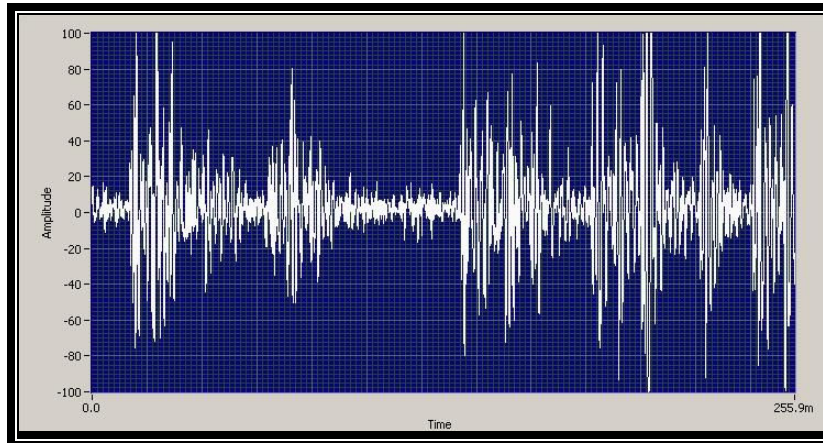
This was very apparent in Mick’s recordings, as the FFT did not represent any discernable footprint that could be linked to an electrical fault. The time domain tells a different story, as it fits the profile of tracking as listed above. A decision was made to come back the following month to see if the condition had further deteriorated. The graphs below indicate what was present in January 2010:

*(Again, variations in time and amplitude)*

Once again, the FFT spectrum yields any useful data with respect to frequency faults or content. The time domain indicated an increase in the intensity of the discharges while taking the measurements at the exact same location on the unit, with the same attachment, frequency setting, sensitivity setting and environmental conditions. (Noteworthy is the “chopping” of the peaks in the time domain. This is remedied by reducing the sensitivity setting on the instrument to avoid signal overload and square-waved displays inhibiting data analysis.)

This suggests that the anomaly had degraded in nature and became worse from a severity point, which altered the action plan and options. The customer was seeking maintenance and testing records on the unit to aid in developing this plan. At the time of this writing, the outcome is still pending, however, the suspicion is that structural movement of the unit and/or bus bar assembly had placed the low voltage connections under stress and possibly damaged the internal structure of the transformer insulating system. This scenario would almost certainly lead to an arcing/tracking event due to compromised insulation and allowing voltage discharges to occur. Results of subsequent testing and inspections will be forthcoming in the near future.

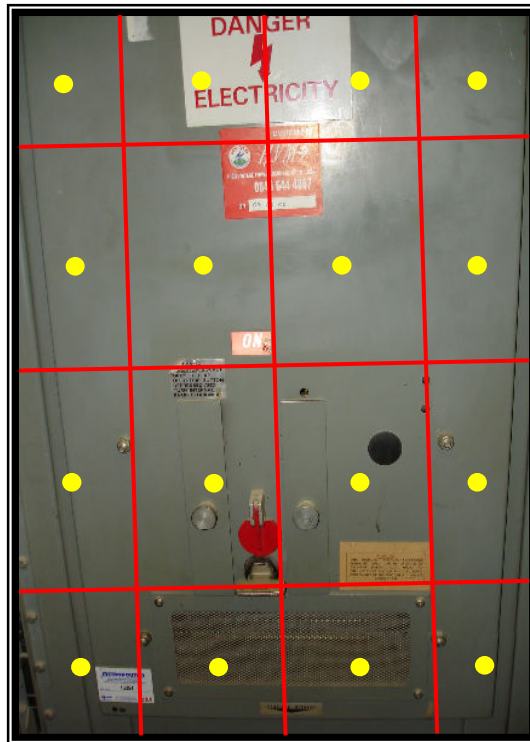
Several positions were selected physically on the exterior of the device to utilize the contact module. An emission was detected, and the recommended procedure of quadrant testing was followed to determine the highest intensity of the anomaly. Below is a picture of the circuit breaker in question, as well as the quadrants from which measurements would be obtained:

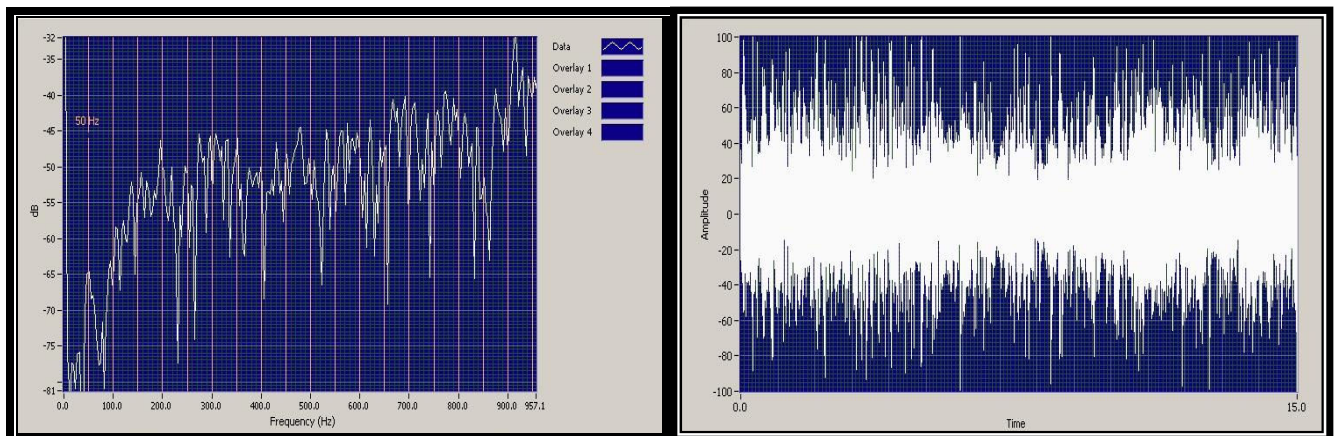
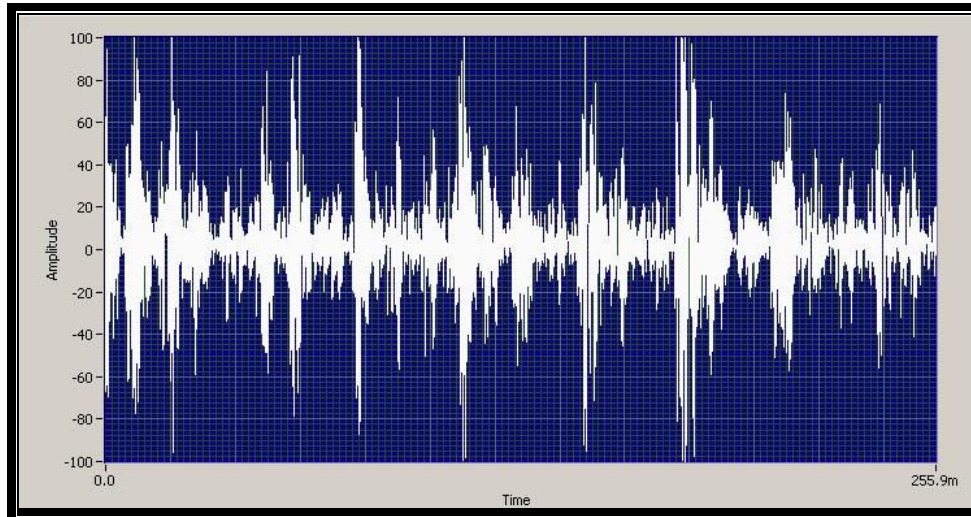
Below are the spectrums generated from the recordings where the signal intensity was highest, in this case near the bottom of the device where the ventilation screen is located:

*(Here once again the illustration of non uniform timing and amplitude)*

The FFT this time indicated some degree of frequency faults present at the 50 Hz harmonics, including a greater abundance of activity within each harmonic (frequency noise content). The time domain also had the characteristic “footprint” one would be in search of relative to a tracking event. The broadband of white noise throughout the recording was accompanied by non-uniform time and amplitude of electrical discharges. This again reinforces the theory that arcing and tracking *cannot* be identified without the use of both FFT and time domain analysis. The FFT tool allows us to determine if it is electrical or mechanical in nature, where the time domain tool tells the real story as to which electrical event we have taking place.

Based on the fact that analysis revealed a high probability that tracking was occurring somewhere in the circuit breaker, planning is in place to perform a closer, more detailed inspection of the circuit breakers and bus connections this August during a scheduled shutdown of the facility. Efforts are also under way to procure a replacement breaker to be retrofitted and installed at the same time.

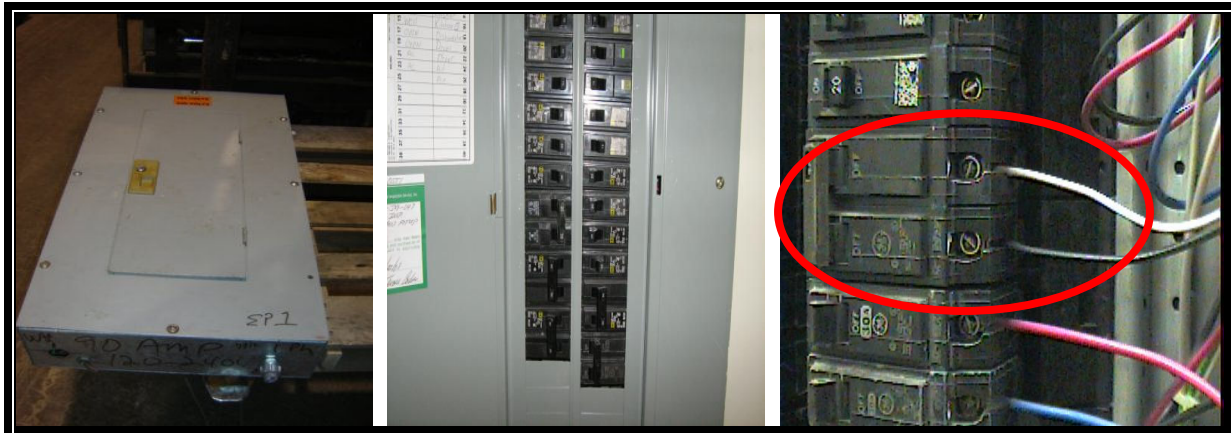
He described a sound in the acoustic isolators (you know them as headphones) that he felt should not be present. The "snap, crackle, pop" characterization came to mind, and he immediately allowed his thought process to drift to tracking as the suspect. The next step was to make a quality recording of the emission and download it to the laptop computer where it could be analyzed with Spectralyzer. Any component that shouldn't have an emission or a tonal quality concern on those that do have some type of ultrasound warrants analysis right there in the field when it is located. An image of the panel type and the actual circuit breaker is seen below:

Aside from the fact that there was a code violation with the use of a "white" conductor as a current-carrying conductor, the ultrasonic emission was cause for alarm. Although one would not believe a simple 30 amp double pole breaker is important enough to justify the efforts, one must take into consideration and investigate what load is served with a given circuit. In this case, the circuit was found to be supplying a central air conditioner unit. But this was not a unit simply for comfort - it serviced the data center in the facility to ensure proper ambient temperatures for operation of the computer networks. This fact added credence to the need to analyze correctly. Once loaded into the software, all the earmarks of a tracking event reared its head. The illustrations below demonstrate once again how both tools clearly expose what is taking place and remove any doubt:

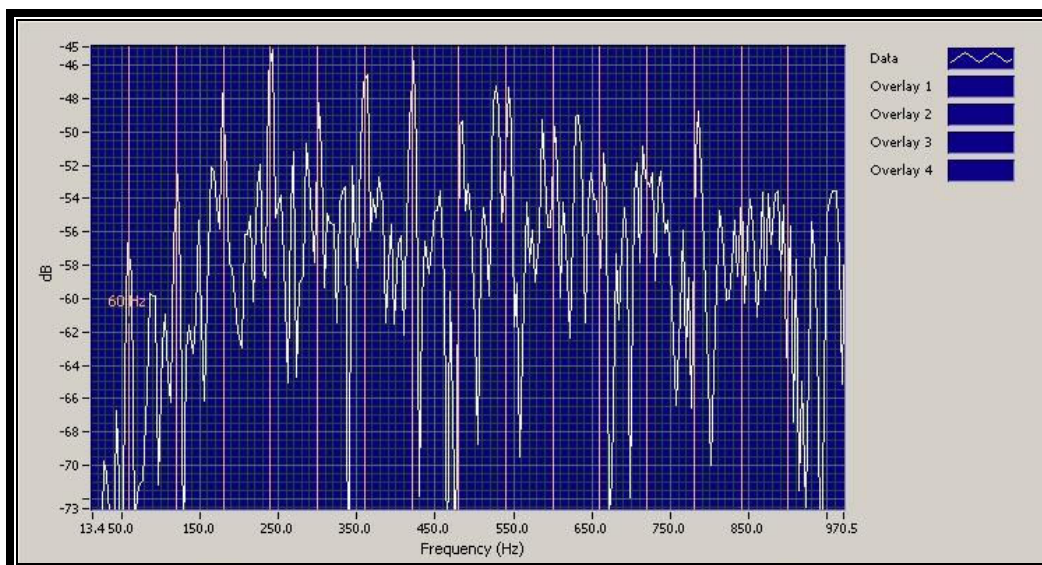
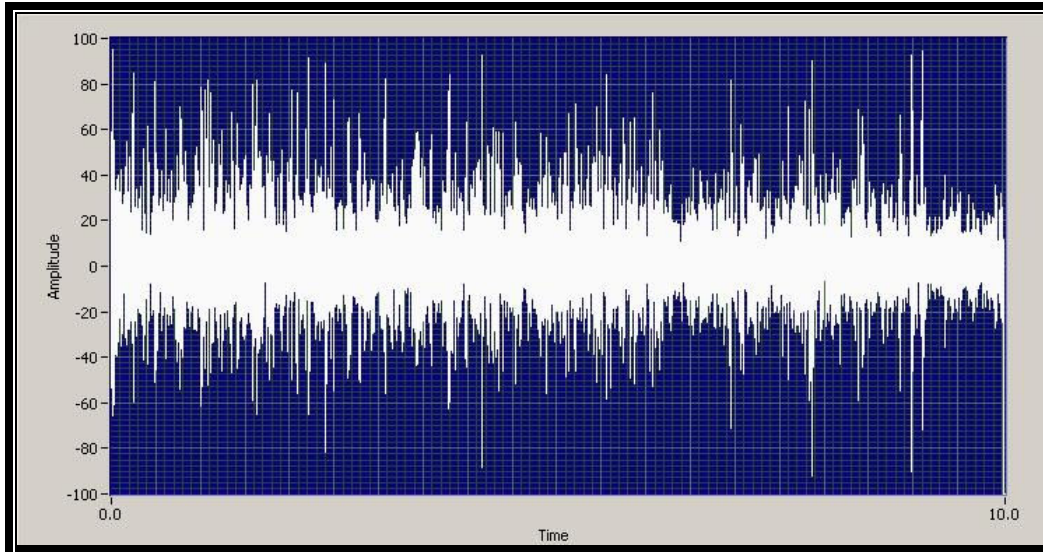
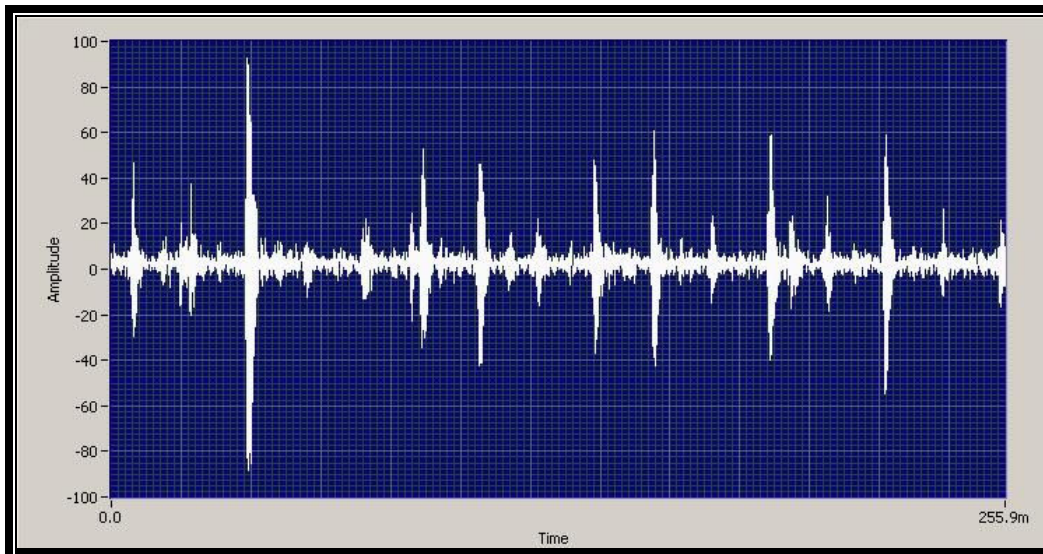
The respective time domain graphs are the proverbial “icing on the cake” for the analysis. All the hallmarks of an electrical tracking event manifest with great clarity and solidify identification of this fault, which degrades with each passing day. The first graph is the entire 10 seconds of recorded tracking, the second a snapshot at the 4-second mark:

***(Great visualization of the footprint exhibiting total non-linearity)***

The intriguing aspect of the above two views relates to the method in which tracking discharges take place along the entire 360-degree electrical cycle. If you recall from Example #2 in which tracking was graphically portrayed, these discharges occur anywhere on a given electrical cycle. As the discharges become more frequent (ergo more severe in nature), you will see the number of excursions increase and become more compacted, suggesting greater numbers of tracks per cycle. This is clearly evident in the first image above displaying the full 10 seconds of recording time.

The second image is a 255 millisecond slice to demonstrate a “magnified” view of this concept. Notice that both the amplitude and spacing of the discharges have no distinct pattern, meaning the intensity and timing are non-linear and present throughout each electrical cycle. Clearly and without reservation, this breaker was deemed to be in the failure mode due to the tracking taking place internally, and was recommended for replacement to avoid a future interruption. The outcome relative to repairs is still pending. The results of the inspection were already presented to the customer, and they will ultimately decide which direction to proceed and with whom. Certainly the customer cannot dispute the value received by this service, professionalism exhibited by the technicians in the application, and the final product report outlining all deficiencies. This is what “service” should be about.
