# **Electrical Equipment “Screams” For Attention!**

## ***Decoding High Frequency “SOS” Calls***

*Joseph Gierlach – Vice President, Technical Training and Support  
TEGG Corporation ~ Pittsburgh, PA*

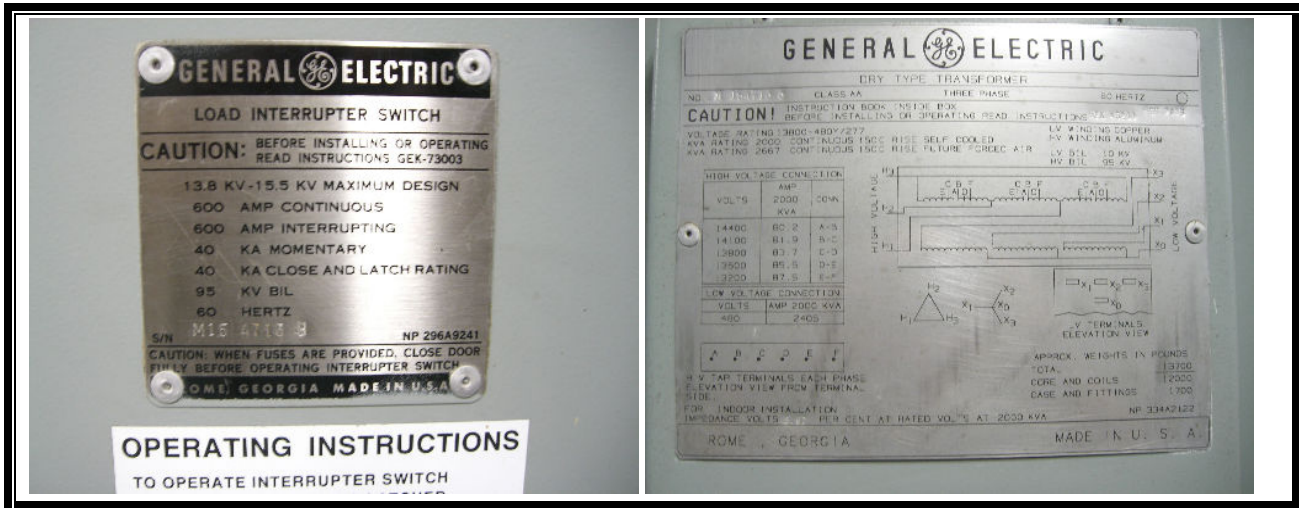
**Figure #1**

As the inspection progressed, Morgan Fowler, lead technician at this time from Transworld Inc., contacted TEGG Corporation personnel to seek opinions of a recording he had secured on one of the 13.8 KV load break switches. This particular switch was one of two identical arrangements that featured the utility feed, a dry 2000 KVA transformer stepping the voltage down to 480/277 volts for distribution to facility equipment. Additionally, this configuration was mirrored on the opposite side of the electrical room to provide redundant supply in the event of an interruption of either of the unit substations. The image in Figure #1 below gives the perspective of the physical lay-out of the one sub:

*(Directly opposite of this is an exact duplicate configuration of the illustration above.)*

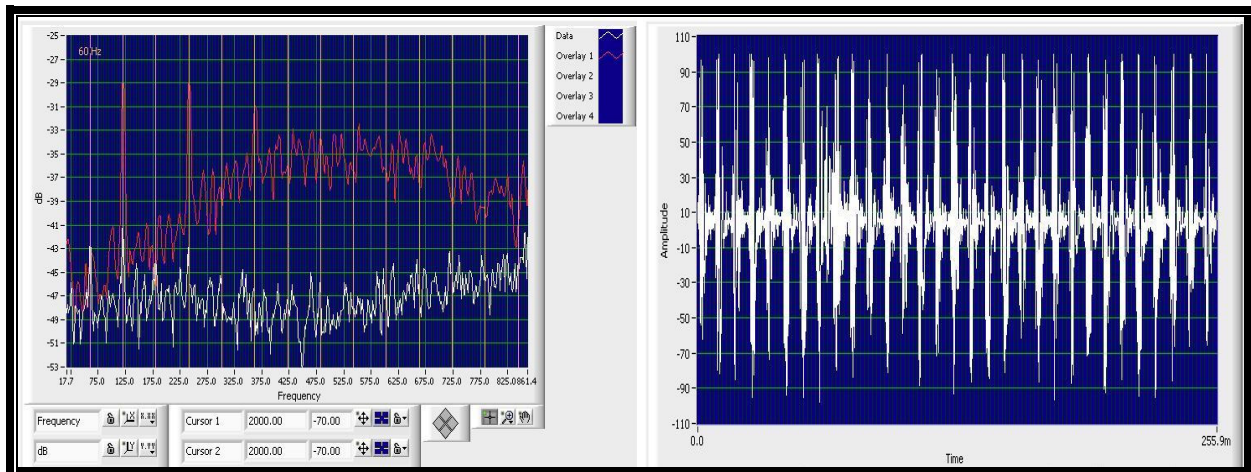
Figure #2

Reviewing what “destructive corona” looks like using the FFT and time domain tools in the Spectralyzer software can be seen below in Figure #2:

The white trace in the FFT illustration is the known sample of destructive corona, and in the time domain on the left, the same event is displayed. FFT demonstrates pronounced 60 Hz “fault frequencies” only in the beginning part of the spectrum, with a drop-off as it moves further along the spectrum. This is unlike “nuisance” corona in which the 60 Hz “fault frequencies” are predominant throughout the spectrum. Both instances of this type of corona will also have an abundance of noise content in between each harmonic frequency.
